SOLANO COMMUNITY COLLEGE TREE REMOVAL PLAN FAIRFIELD, CALIFORNIA

SOLANO COMMUNITY COLLEGE, VACAVILLE CENTER TREE REMOVAL PLAN VACAVILLE, CALIFORNIA

SOLANO COMMUNITY COLLEGE, VALLEJO CENTER TREE CARE PLAN VALLEJO, CALIFORNIA

Site Summary

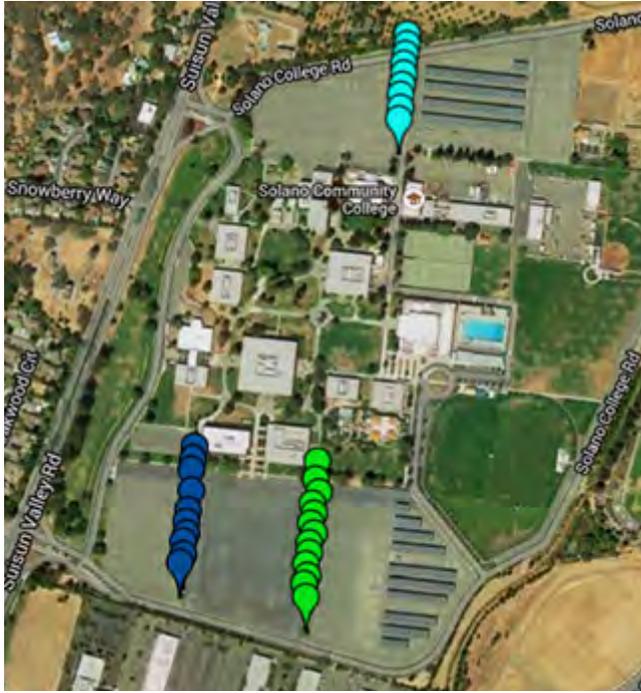
Camphors, Sycamores, and Olives in parking lots.

The following trees have caused concrete deformation of the divider. (ie. Pavement and curb). In addition, some of the mentioned trees that are leaning could be a potential hazard to the property.

Level of hazard for Sycamores and Camphors: Medium to High depending on automobile traffic.

Level of hazard for Olives: Low

Approximated cost of Removals: \$15,110.00
Approximated cost of Grind Stumps: \$4,390.00

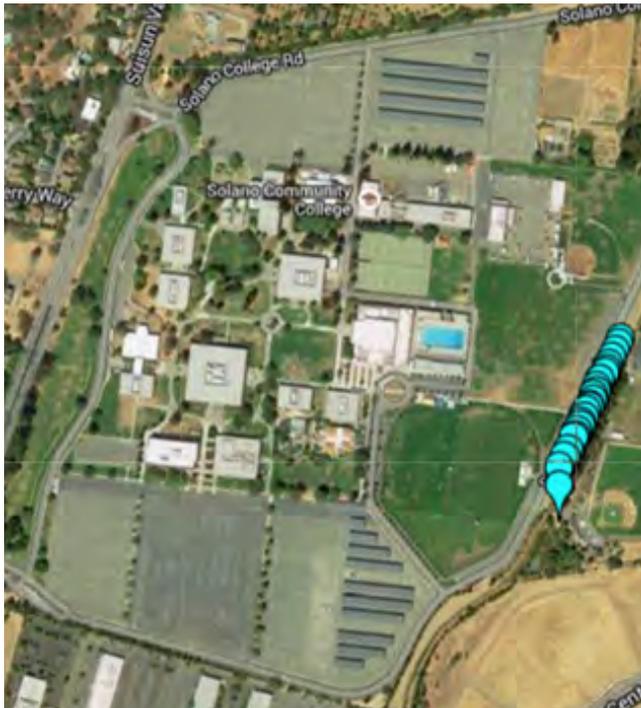
Aleppo Pines along Solano College Road (Baseball field).

The following trees have caused concrete deformation of the divider. (ie. Pavement and curb). In addition, some of the mentioned trees that are leaning could be a potential hazard to the property.

Level of hazard: Medium, dependent on pedestrian traffic.

Approximated cost of Removals: \$15,110.00
Approximated cost of Grind Stumps: \$4,390.00

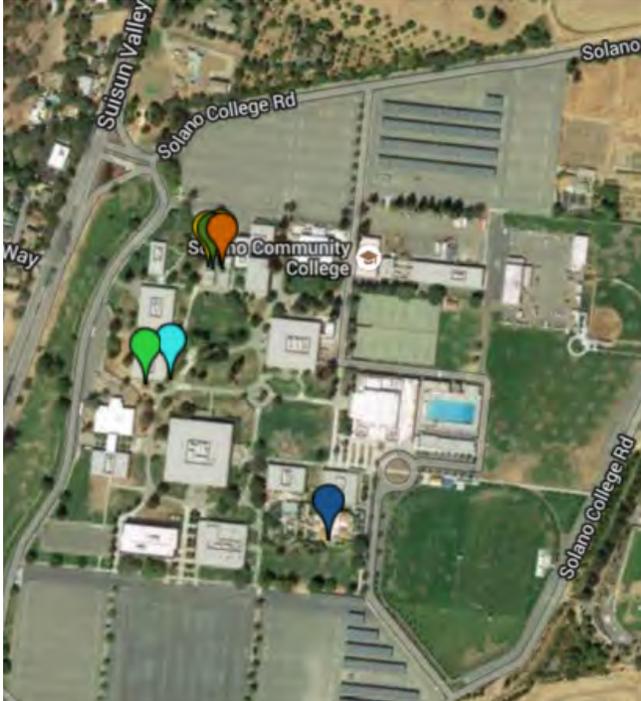
Trees planted near buildings

These trees (Alder, Eucalyptus, Elm, Cherry, etc.) are planted too close to building proximities. The reason for the recommendation is the fact that it could cause potential damage to the foundation of buildings. Also, due to their close distance to the buildings, these trees will constantly need clearance pruning and it would be more cost-effective in the long run to remove the tree instead.

Level of hazard: Low

Approximated cost of Removals: \$ 2,425.00

Approximated cost of Grind Stumps: \$ 640.00

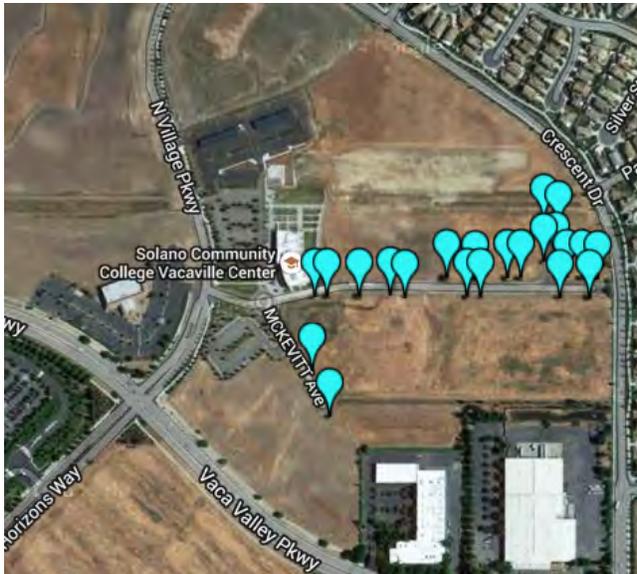
The majority of White Alders presented presents poor structure and displays multiple signs of broken limbs. Some of the trees in the area have declining canopies. The trees is recommended to be removed due to health and structural reasons. In addition, if the campus plans to expand, the trees should also be removed for aesthetic reasons.

Level of hazard: low

Approximated cost of Removals: \$10,150.00

Approximated cost of Grind Stumps: \$3,160.00

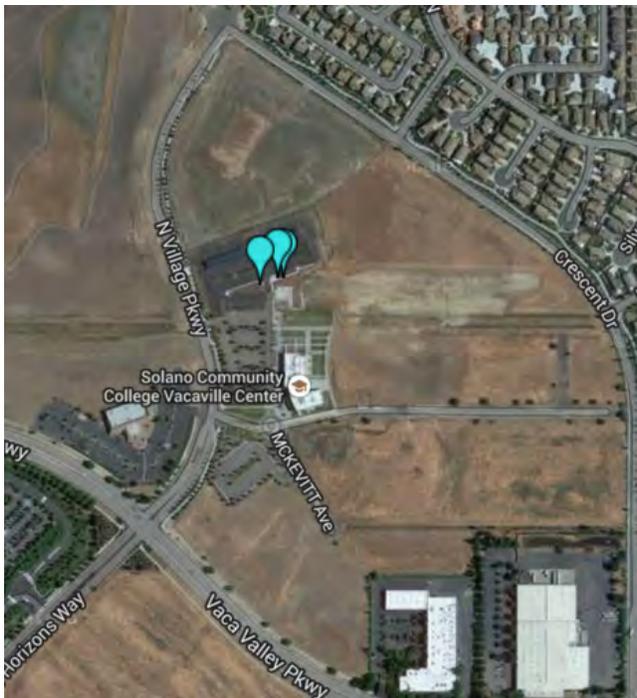
Young Redwood trees in the parking lot

The canopy had diedback and eighty percent of the foliage had declined.

Level of hazard: None

Approximated cost of Removals: \$180.00

Approximated cost of Grind Stumps: \$ 0.00

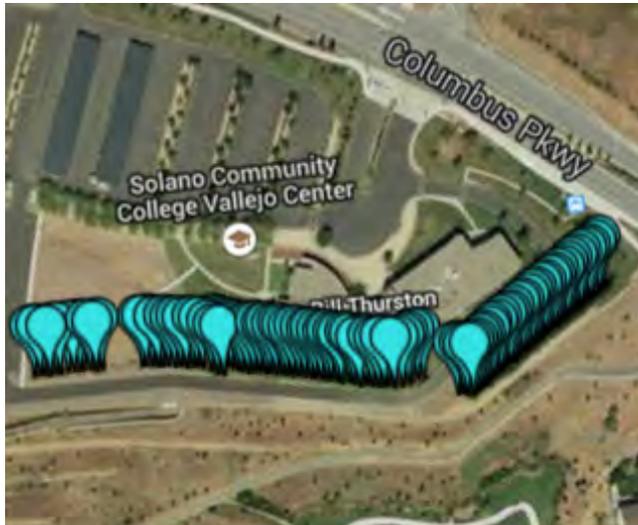
Lombardy Poplar

Future thinning to allow strong wind pressure to easily pass through the canopy.

Level of hazard: None

Approximated cost of Crown Thin: \$ 4, 771.00

Cost of stake removal: \$ 0.00
