ADDENDUM # 03
	SCCD RFP: # 14-014
	Project: Solano Community College District Theater Renovation
	Date: 08/13/2015

**Addendum # 03 – The following clarifications are provided based on questions received and must be added/considered when completing your submittal:** Acknowledgement of receipt of this **ADDENDUM** is required in the proposal’s cover letter of introduction. Please clearly note the addendum date and number.

BUILDING 1200 THEATER RENOVATION  
INCREMENT 2  
4000 SUISUN VALLEY ROAD, FAIRFIELD, CA

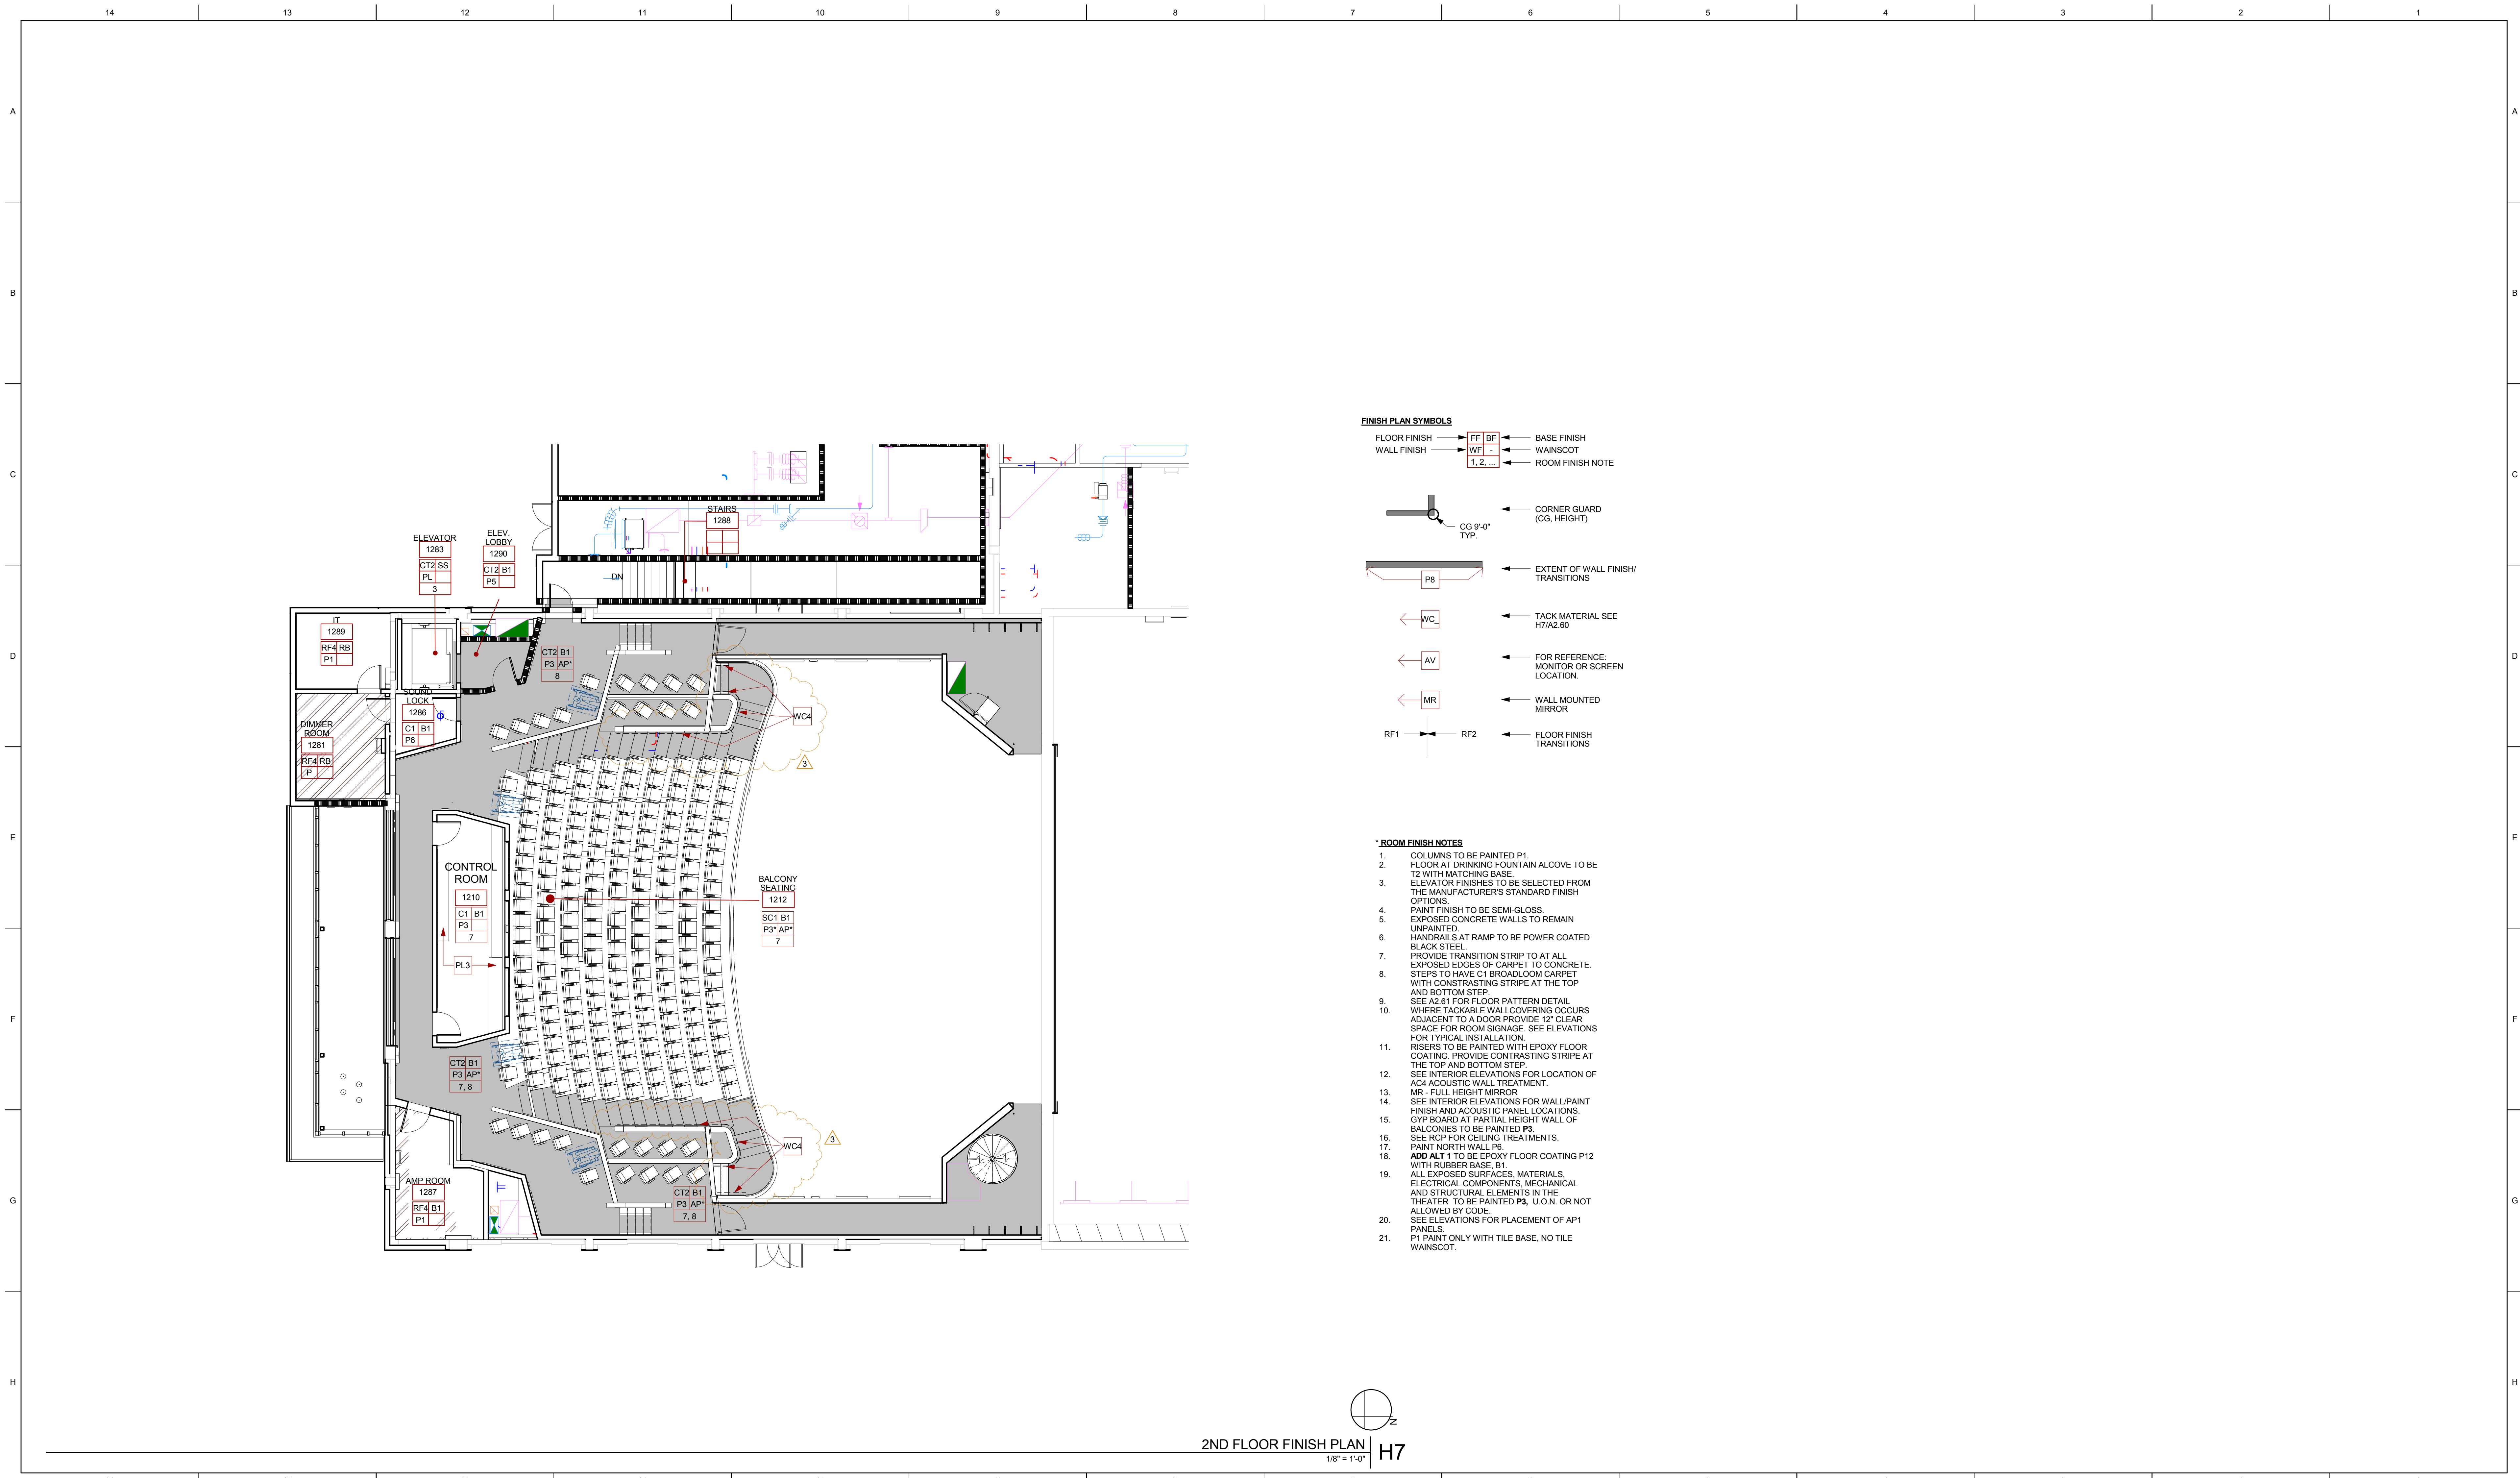
# A2.61

- In CORRIDOR 1224 added WC4
  - In CORRIDOR 1254 added WC5
5. Sheet A2.62
- On left and right hand sides of BALCONY SEAT 1212 added WC4.
6. Sheet A2.81
- On door 1227 changed hardware group from 14 to 10.
  - On door 1253.3 changed;
    - Door type to (E)
    - Door material to (E)
    - Frame type to (E)
    - Frame material to (E).
7. Sheet A9.55
- Revised details B4, B6, D4, D6, F4 AND F6. Details were changed to remove timely knockdown type to standard heavy-duty hollow metal with fully welded frames.
8. Sheet A3.22
- Revised building section H1 at ELEVATOR EQUIPMENT ROOM 1219.
9. Sheet M2.2
- Added fire smoke damper to practice room 1261 in the 10x10 supply duct.

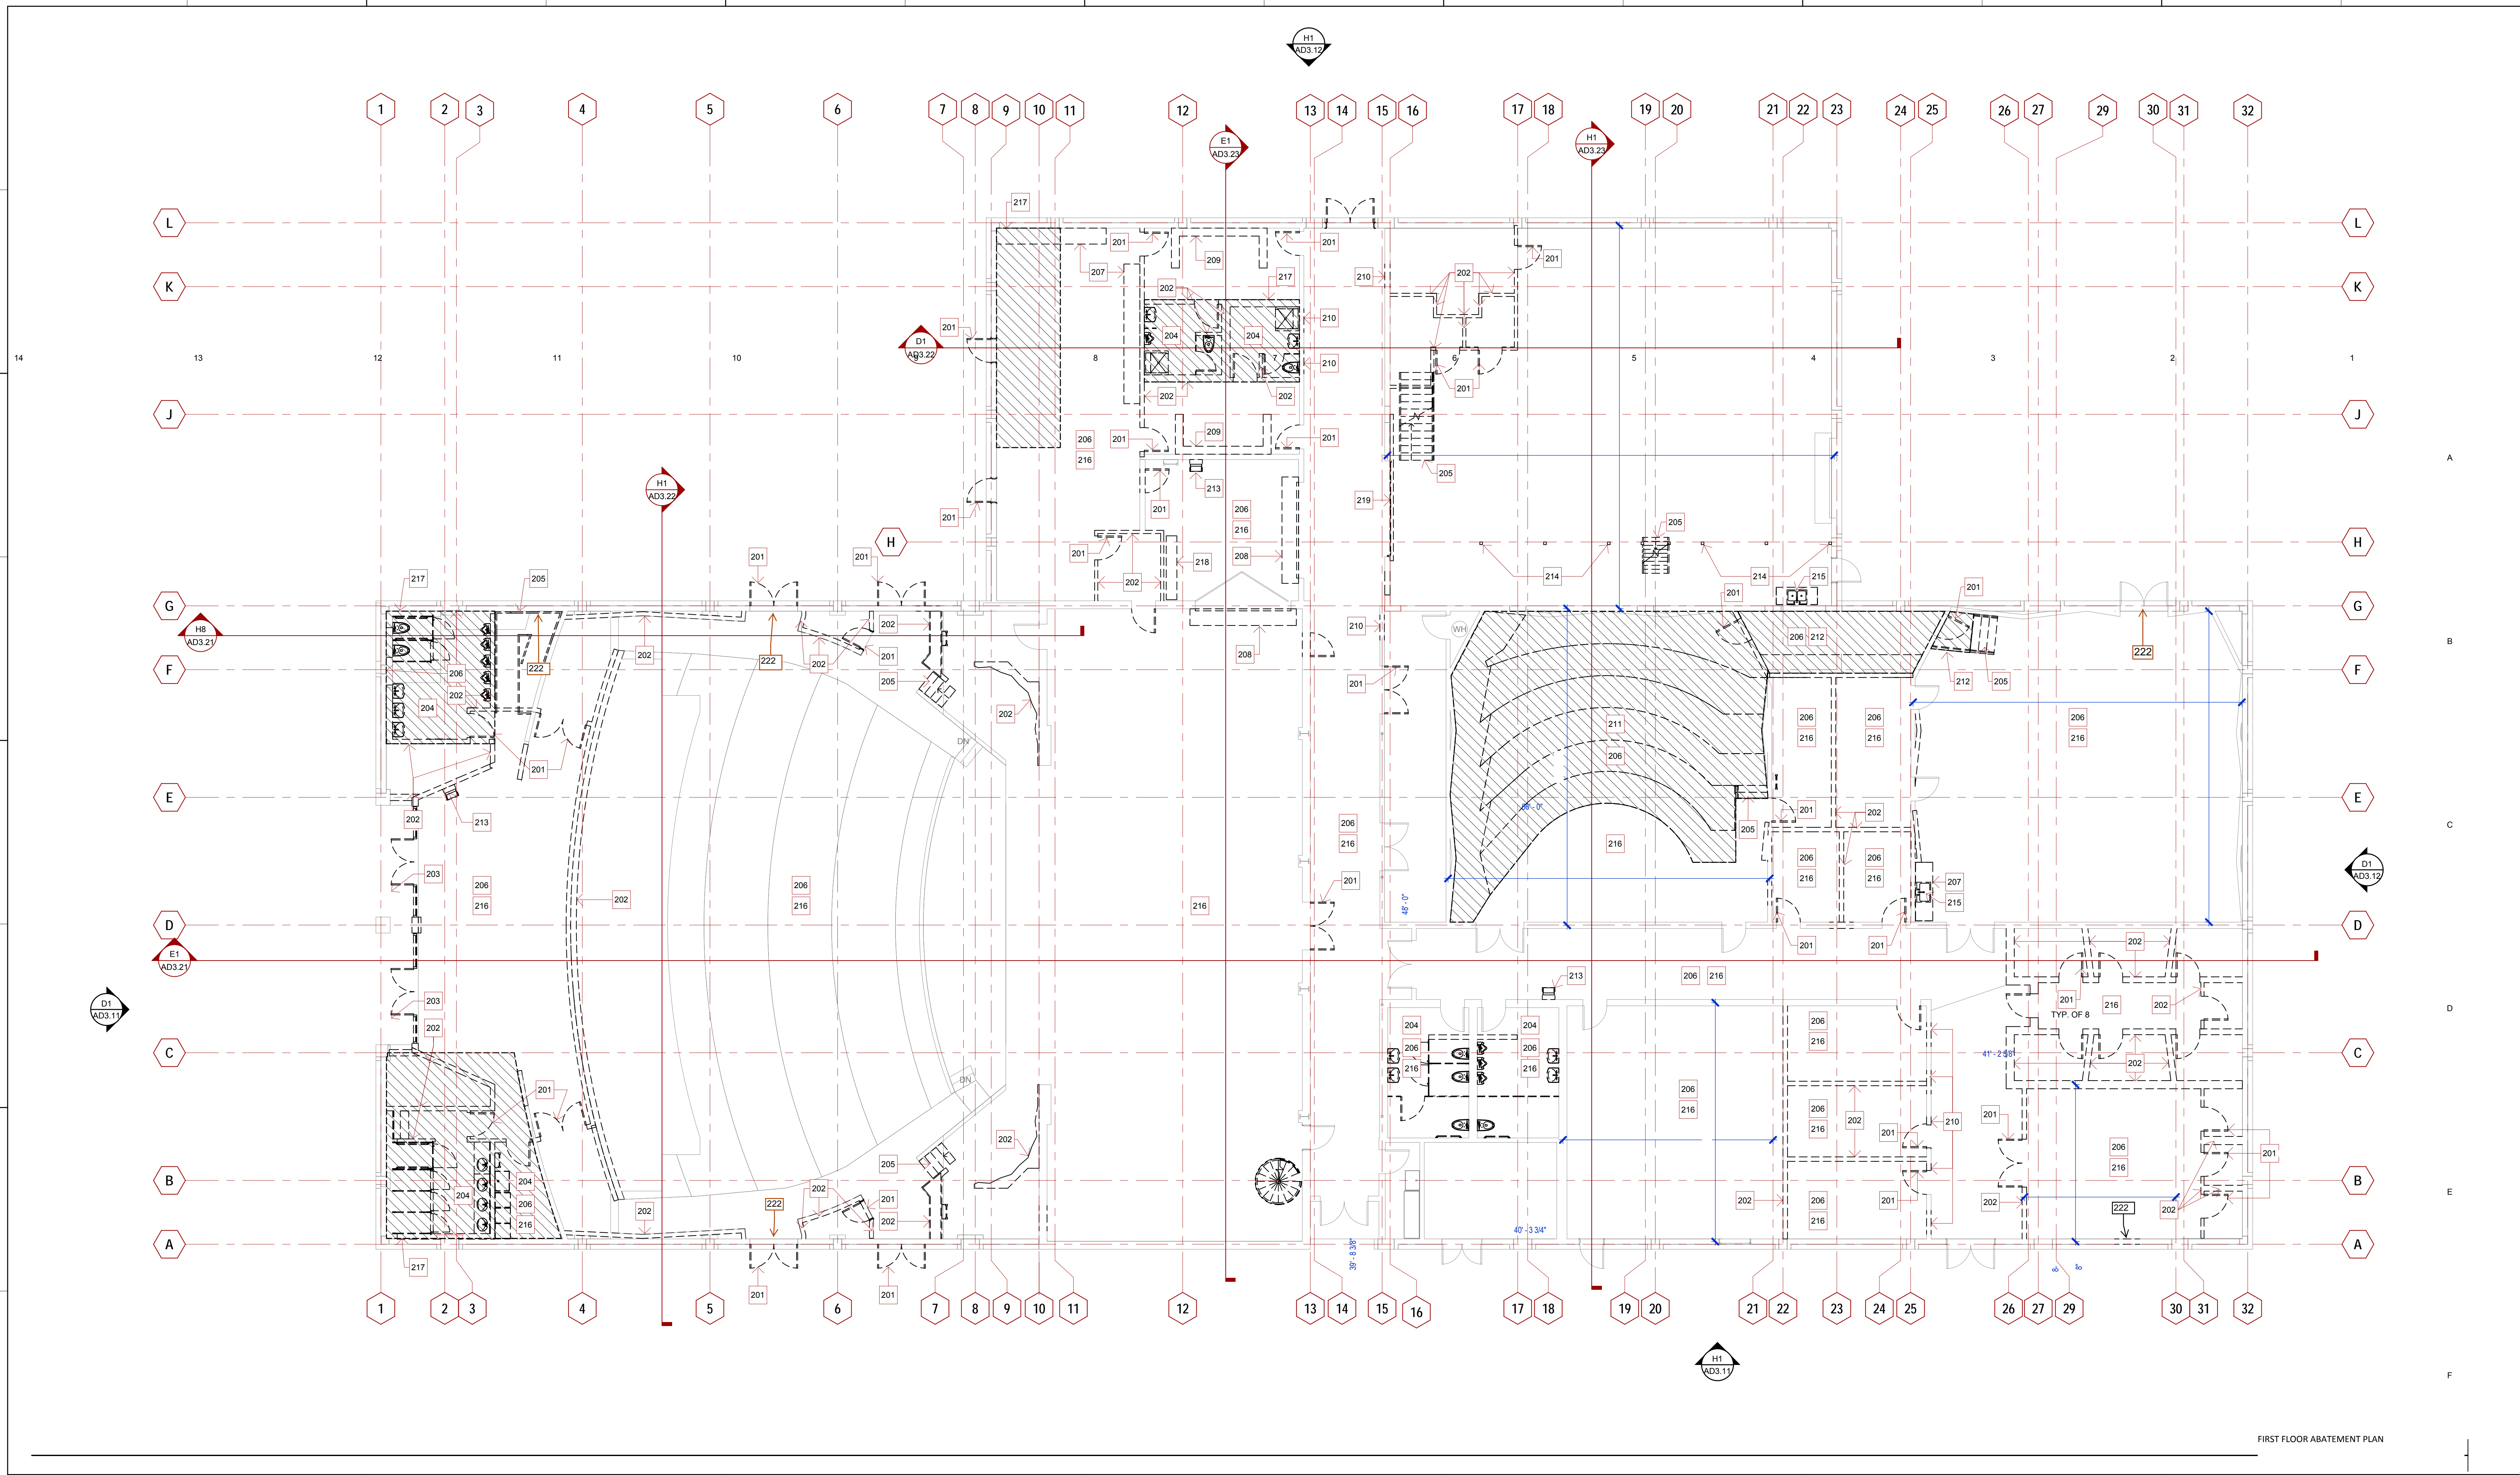
FIRST FLOOR ABATEMENT PLAN

- ABATEMENT NOTES:
- 201 REMOVE ASBESTOS EXTERIOR DOOR FRAME SEALANT. TYP. - DISPOSE AS ASBESTOS CONTAINING WASTE
  - 202 REMOVE EXISTING DRYWALL, WALL FINISH, AND FRAMING MEMBERS. ABATE ALL DRYWALL/JOINT COMPOUND. TYP. - DISPOSE AS A REGULATED ASBESTOS CONTAINING MATERIAL (RACM)

- 203 NOT APPLICABLE WITH HAZARDOUS MATERIAL ABATEMENT
  - 204 REMOVE EXISTING PLUMBING FIXTURES, CASEWORK, AND TOILET PARTITIONS - GENERAL DEMOLITION DEBRIS

- 205 NOT APPLICABLE WITH HAZARDOUS MATERIAL WORK
  - 206 REMOVE EXISTING DRYWALL FINISH DOWN TO FRAMING MEMBERS - DISPOSE AS REGULATED ASBESTOS CONTAINING MATERIAL (RACM)

- 207 REMOVE EXISTING CASEWORK IN ORDER TO ACCESS ASBESTOS DRYWALL - GENERAL DEMOLITION DEBRIS
  - 208 NOT APPLICABLE WITH HAZARDOUS MATERIAL ABATEMENT

- 209 REMOVE EXISTING LOCKERS - GENERAL DEMOLITION DEBRIS
  - 210 NOT APPLICABLE WITH HAZARDOUS MATERIAL ABATEMENT
  - 211 REMOVE FLOOR FINISH ONLY - DISPOSE AS ASBESTOS CONTAINING MATERIAL

222 REMOVE EXISTING MOISTURE BARRIER TYP. ALL NEW EXTERIOR PENETRATIONS - DISPOSE AS NON-FRIABLE ASBESTOS CONTAINING MATERIAL - ADDENDUM #1 3/20/15

1. Hazmat Sheets HAZ.01 and HAZ.02.
  - Sheets were revised and included in Addendum 01, but not listed on the Addendum 01 narrative. Changes indicated in Keynotes.
2. Hazmat Sheet HAZ.03
  - Removed in Addendum 01. Added back into project in this Addendum (03) as it appeared prior to Addendum 01. No change to drawing.

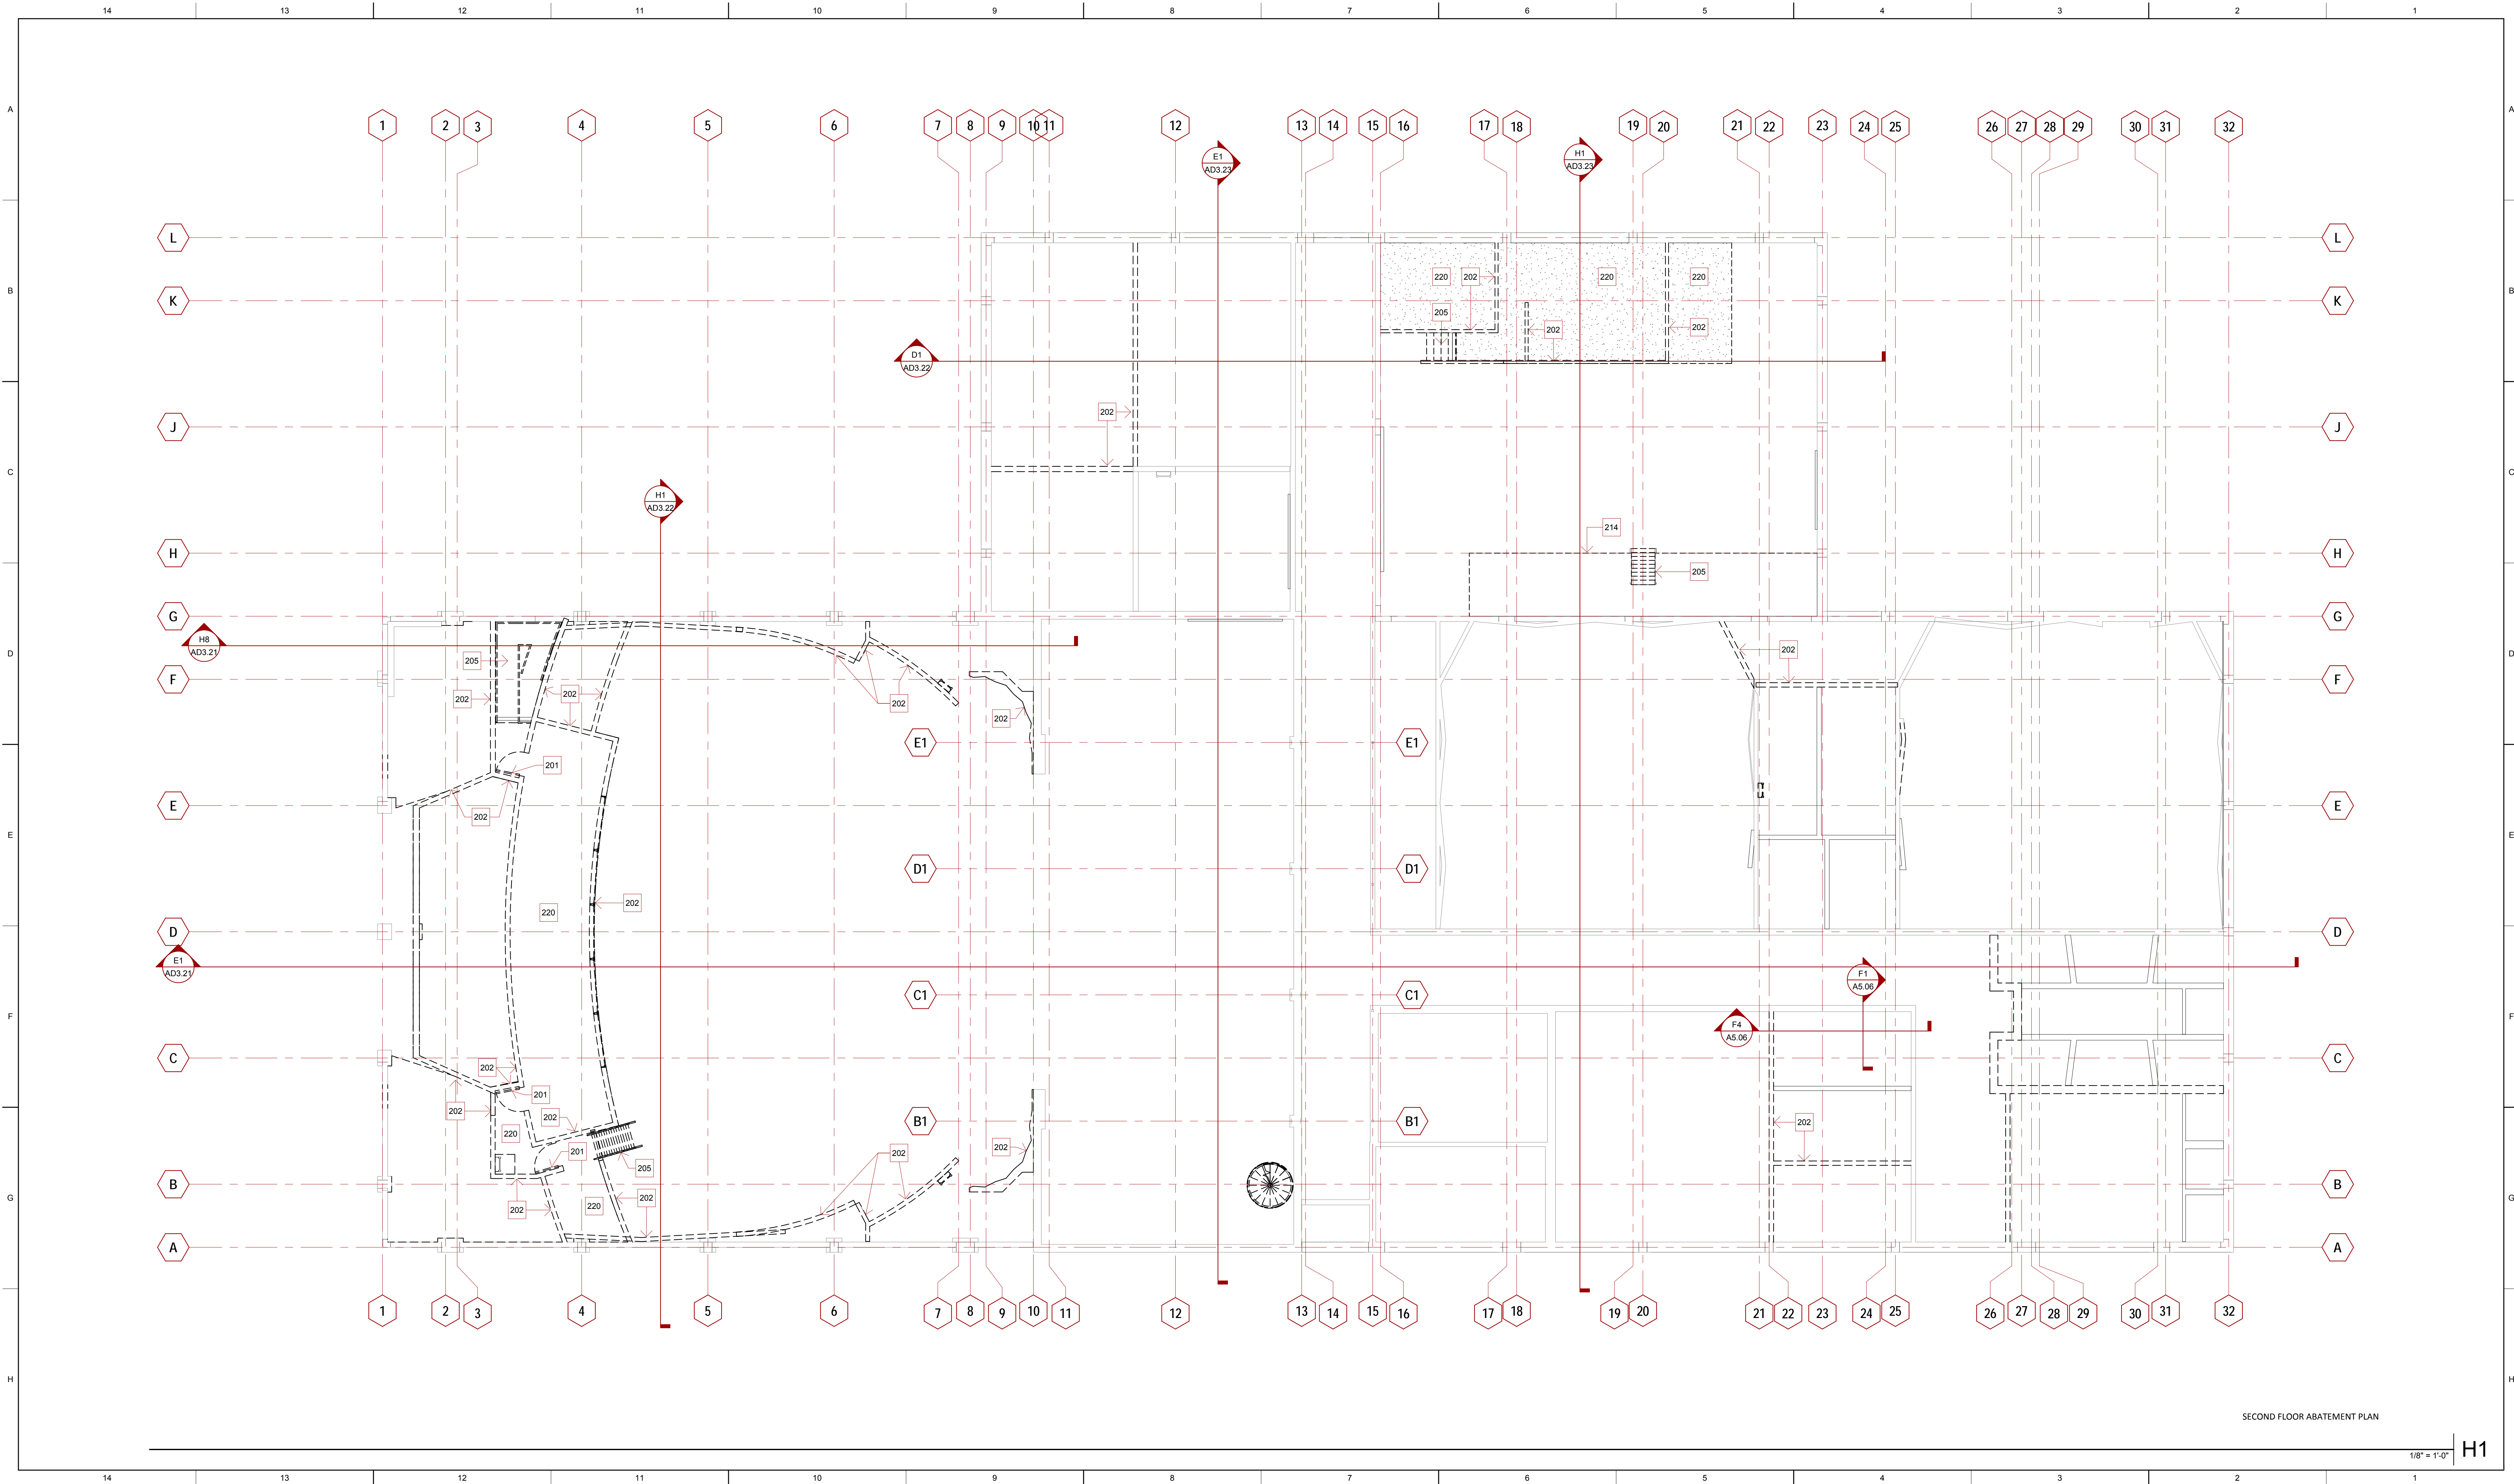
HAZ.02

SECOND FLOOR ABATEMENT PLAN

ABATEMENT NOTES:  
 201 REMOVE EXTERIOR DOOR FRAME SEALANT. TYP - DISPOSE AS ASBESTOS CONTAINING MATERIAL.  
 202 REMOVE EXISTING DRYWALL, WALL FINISH, AND FRAMING MEMBERS. ABATE DRYWALL/JOINT COMPOUND. TYP - DISPOSE AS REGULATED ASBESTOS CONTAINING MATERIAL (RACM).  
 205 NOT APPLICABLE WITH HAZARDOUS MATERIAL WORK.  
 214 NOT APPLICABLE WITH HAZARDOUS MATERIAL ABATEMENT.  
 220 REMOVE EXISTING FLOORING - ABATE 9" VFT AND 12" VFT AND MASTIC. TYP - DISPOSE AS ASBESTOS CONTAINING WASTE.

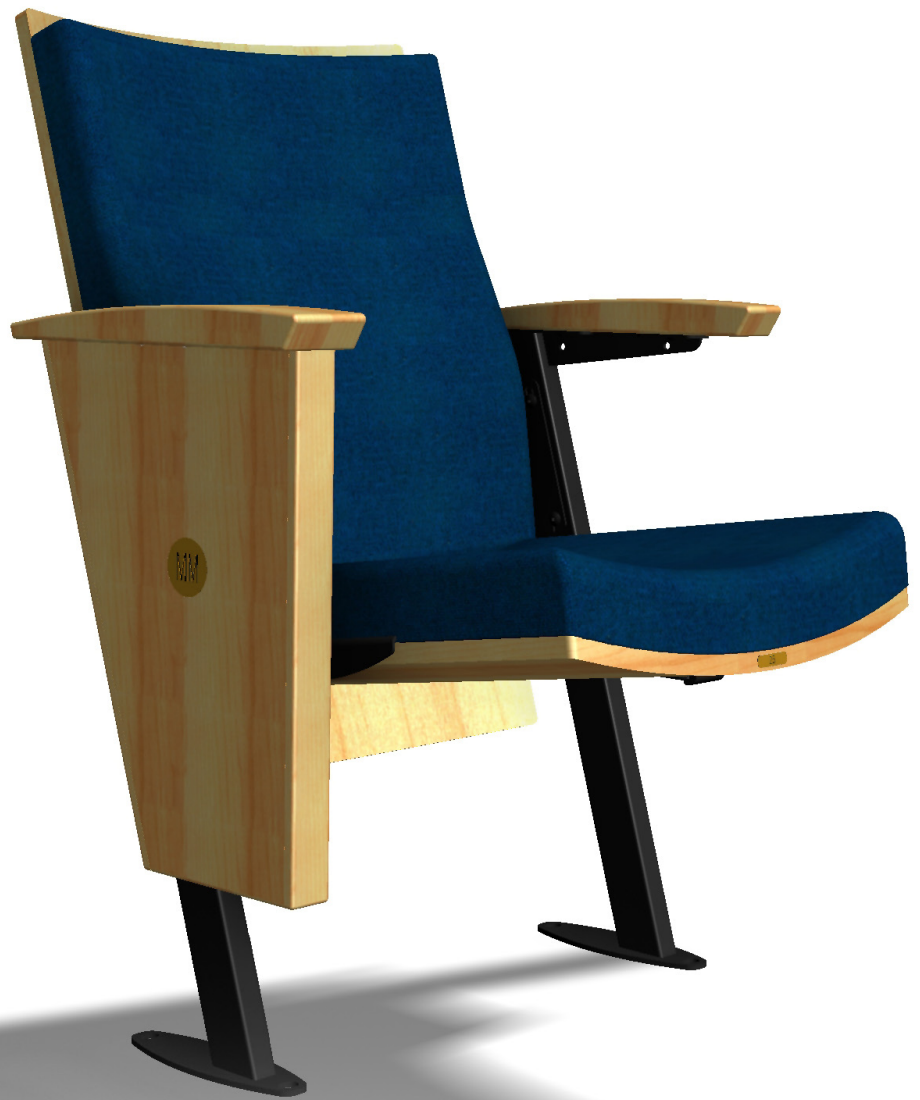
# SYMPHONY

Designed for Theatres, PACs and Auditoriums, the Symphony seat and backrest are composed of comfortable and pleasantly shaped foam. The sleek lines of the seat and back are aligned in a harmonious position that gives the seat all the lateral and longitudinal rigidity needed for its use without compromising comfort and durability. Available is either floor or riser mounted versions.
