PMP Environmental Consulting
5325 Elkhorn Blvd. #360, Sacramento, CA 95842
(916) 628-5124 • PMPEnvConsulting@gmail.com

January 16, 2026

This letter contains the results of a hazardous material survey carried out in Building 1400, located at 4000 Suisun Valley Road, Fairfield, California on the Solano Community College Campus. This survey was performed for a lighting upgrade project. A list of suspect materials identified and sampled are included in this report. The inspection was conducted on January 12-13, 2026, by Shannon Johanson and Mason Johanson. Mrs. Johanson is a Cal/OSHA Certified Asbestos Consultant and EPA-accredited Building Inspector and California Department of Public Health Certified Inspector Assessor and Project Monitor. Mr. Johanson is an EPA-accredited Building Inspector and California Department of Public Health Certified Lead Sampling Technician. See attached personnel certifications.

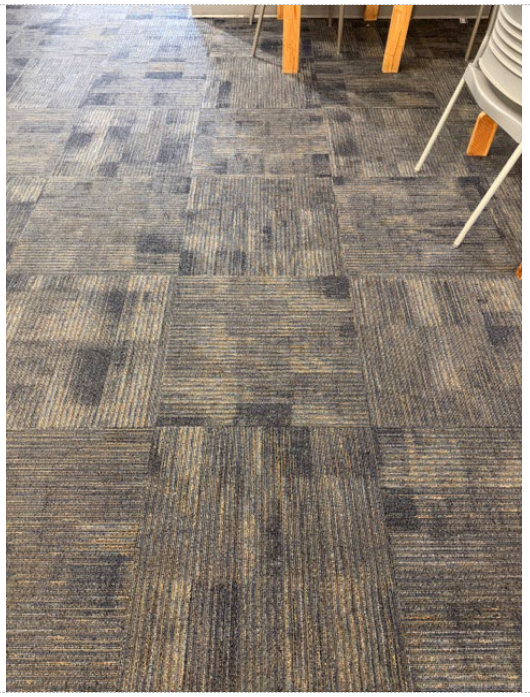
Black/Brown carpet tile

Gray/green carpet tile

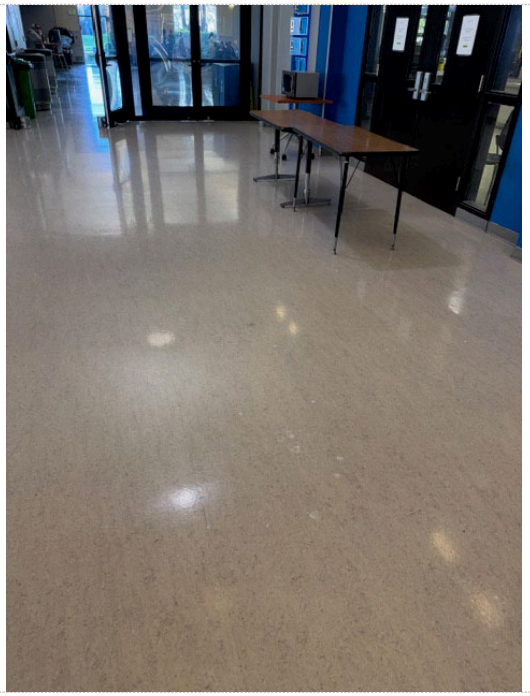
Light gray marble sheet vinyl flooring

Faculty Kitchen-Green sheet vinyl flooring

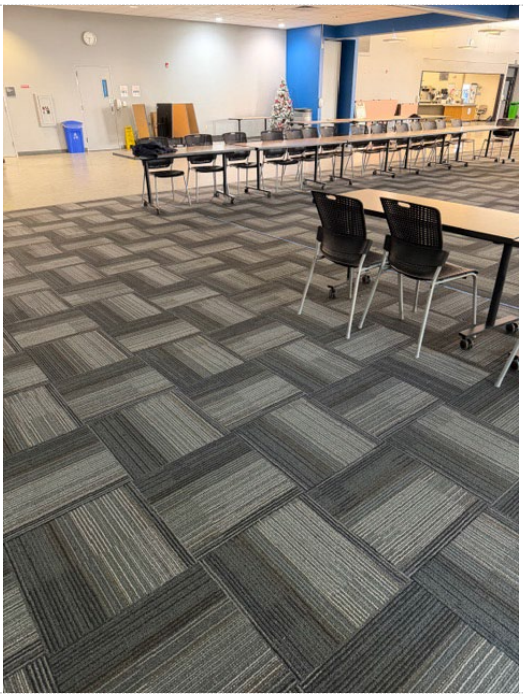
Sitting Area-Blue/Gray/Brown Carpet Tile

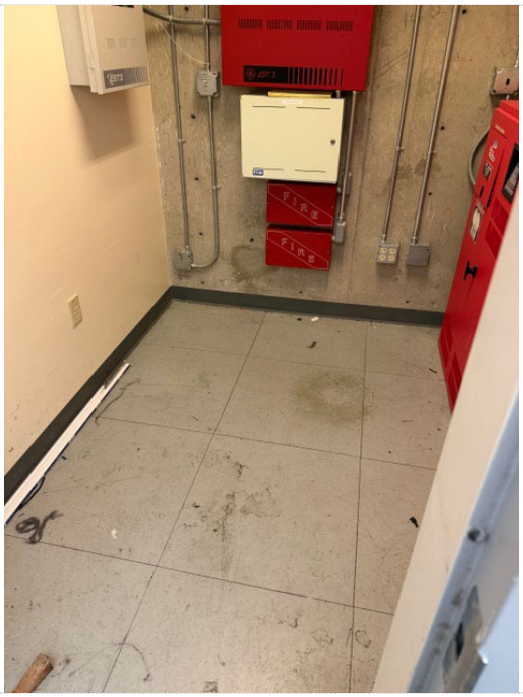
Electrical Room - 2’ VFT & Mastic

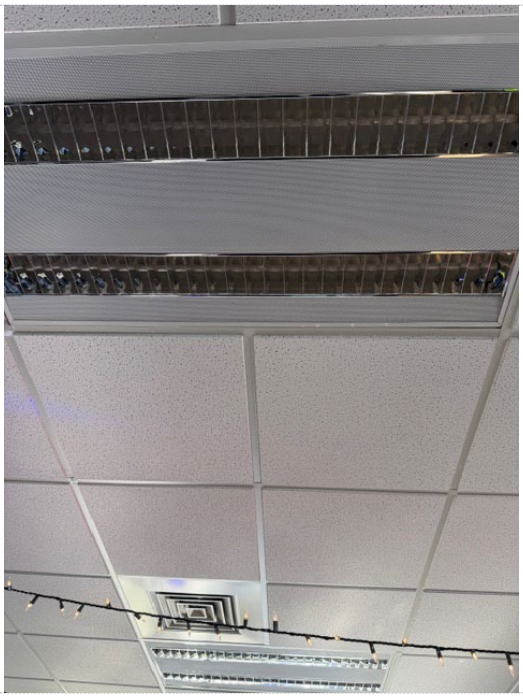
Ceiling/Existing Lighting

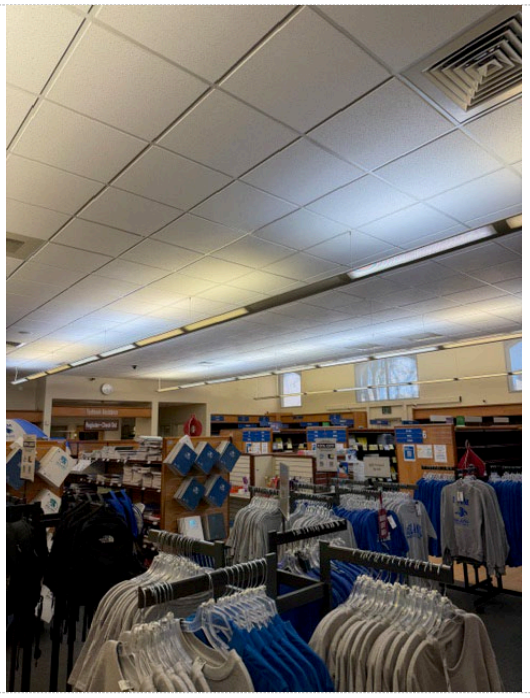
Book Store

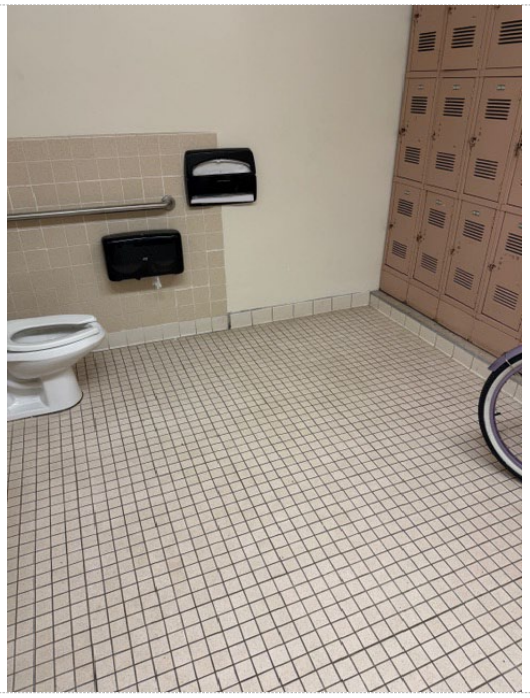
Kitchen Staff Restroom-Lead Tiles

The Cal/OSHA Lead in Construction Standard (8 CCR 1532.1) should be followed for any activities that will disturb the painted coatings in the project area that are listed as lead-containing. This is recommended as the standard applies to lead-related construction activities containing any detectable amount of lead. It's recommended that the contractor use HEPA shrouded equipment when sanding, cutting, etc. to eliminate the potential for lead dust and worker exposure.
